MARYLAND HISTORICAL TRUST  
NR-ELIGIBILITY REVIEW FORM

Property Name: Feaga-Albaugh Farmstead Inventory Number: F-3-226

Project: Proposed Cannon Bluff Subdivision Agency: Horizon Frederick II LLC

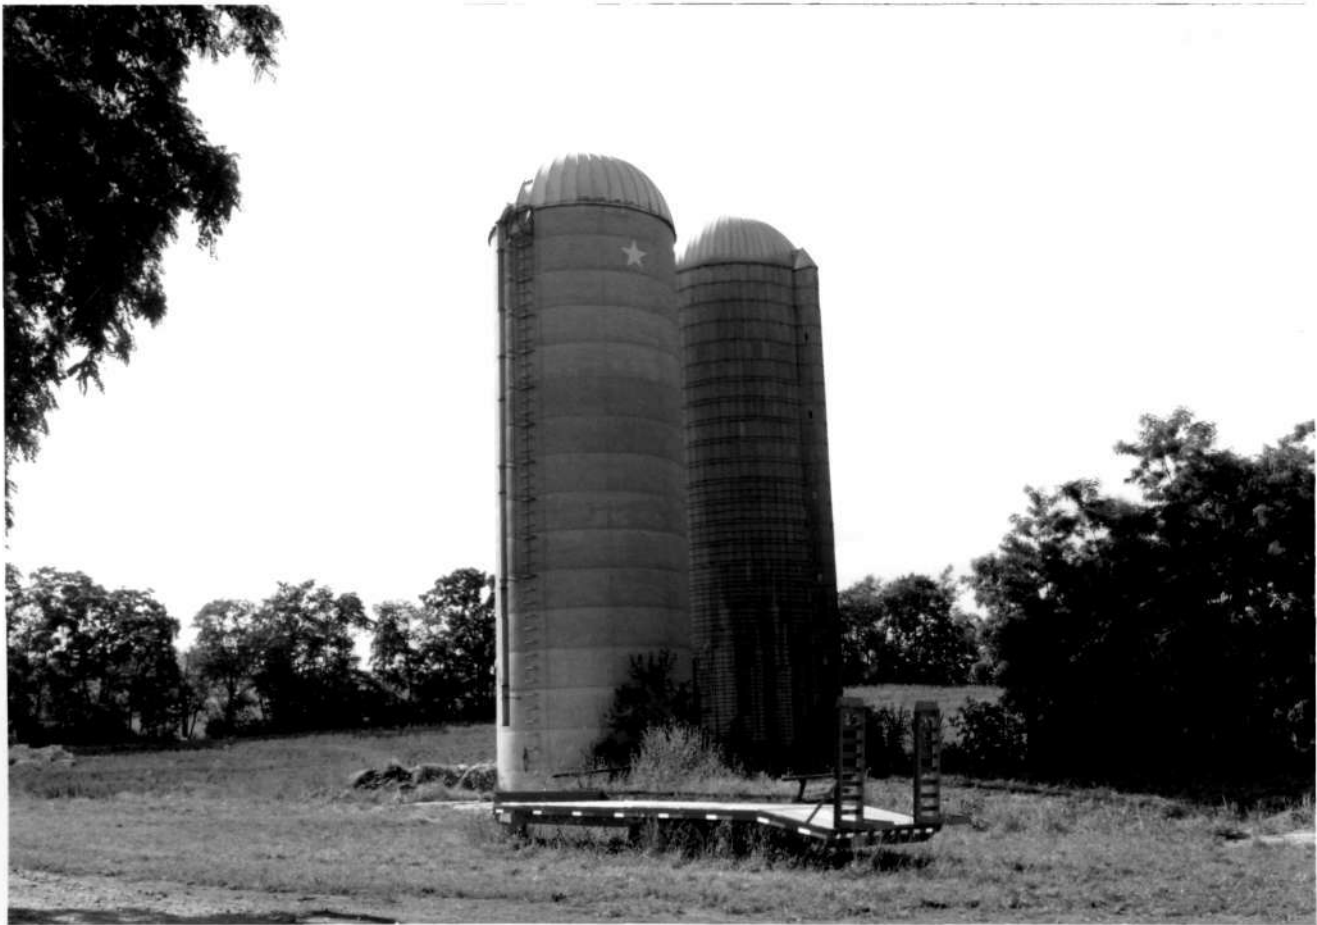
16/21

Large concrete silos- view NW

Two large, concrete silos with metal domes are located west of the bank barn. The north silo features circular steel bands and appears to date to the mid-twentieth century. The south silo was probably constructed mid-to-late twentieth century. A poured-concrete trough with a metal conveyor system is located east of the two silos. The trough lies in a depression that features poured-concrete walls and floor. The silos are in good condition.

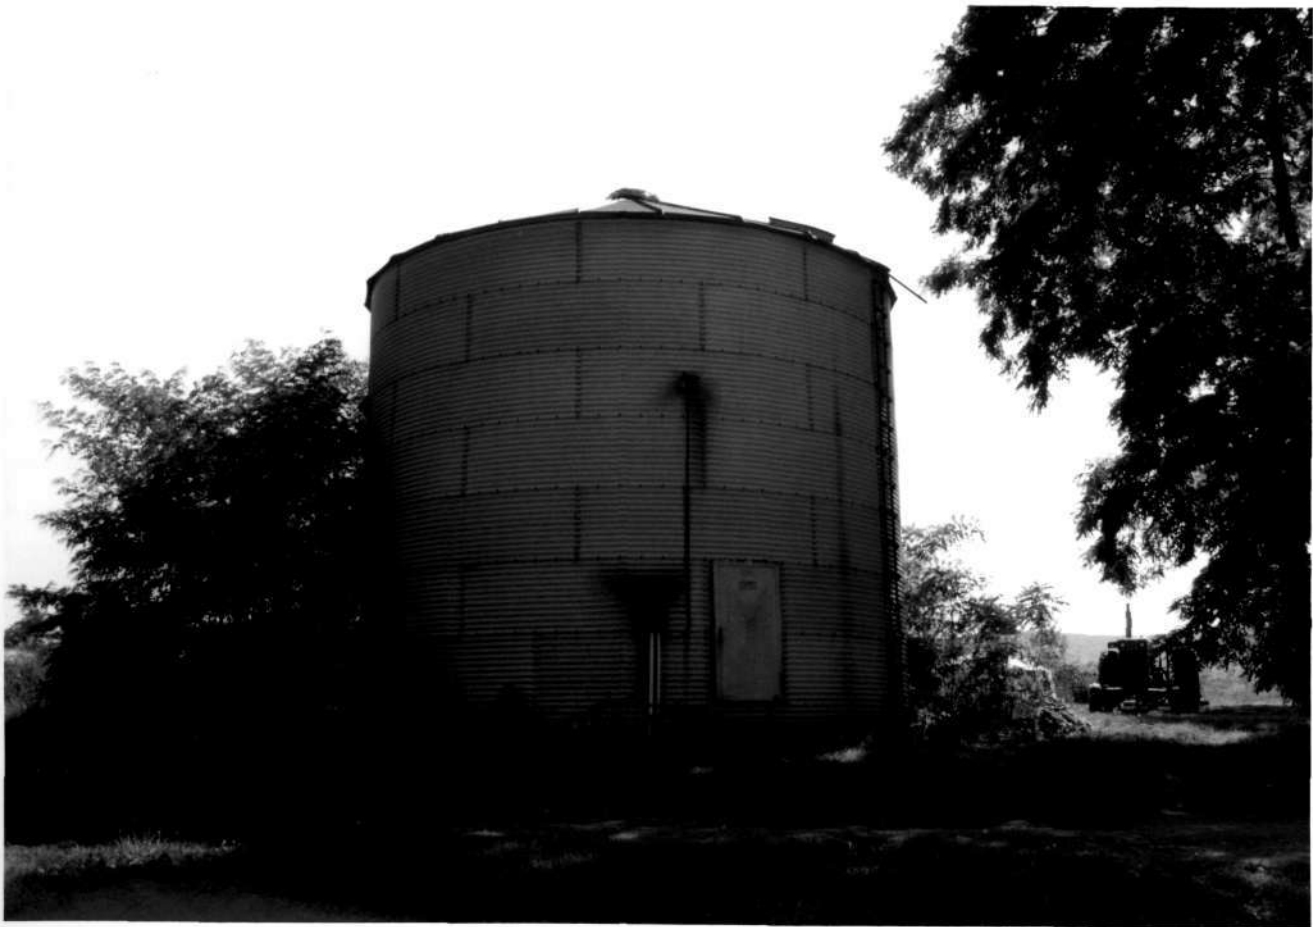
17/21

Large metal grain bin - view SW

A large, cylindrical, metal grain bin is located south of the bank barn. The mid-to-late twentieth century bin rests on a concrete platform and features a conical roof sheathed in standing-seam metal. The grain bin is in fair condition.

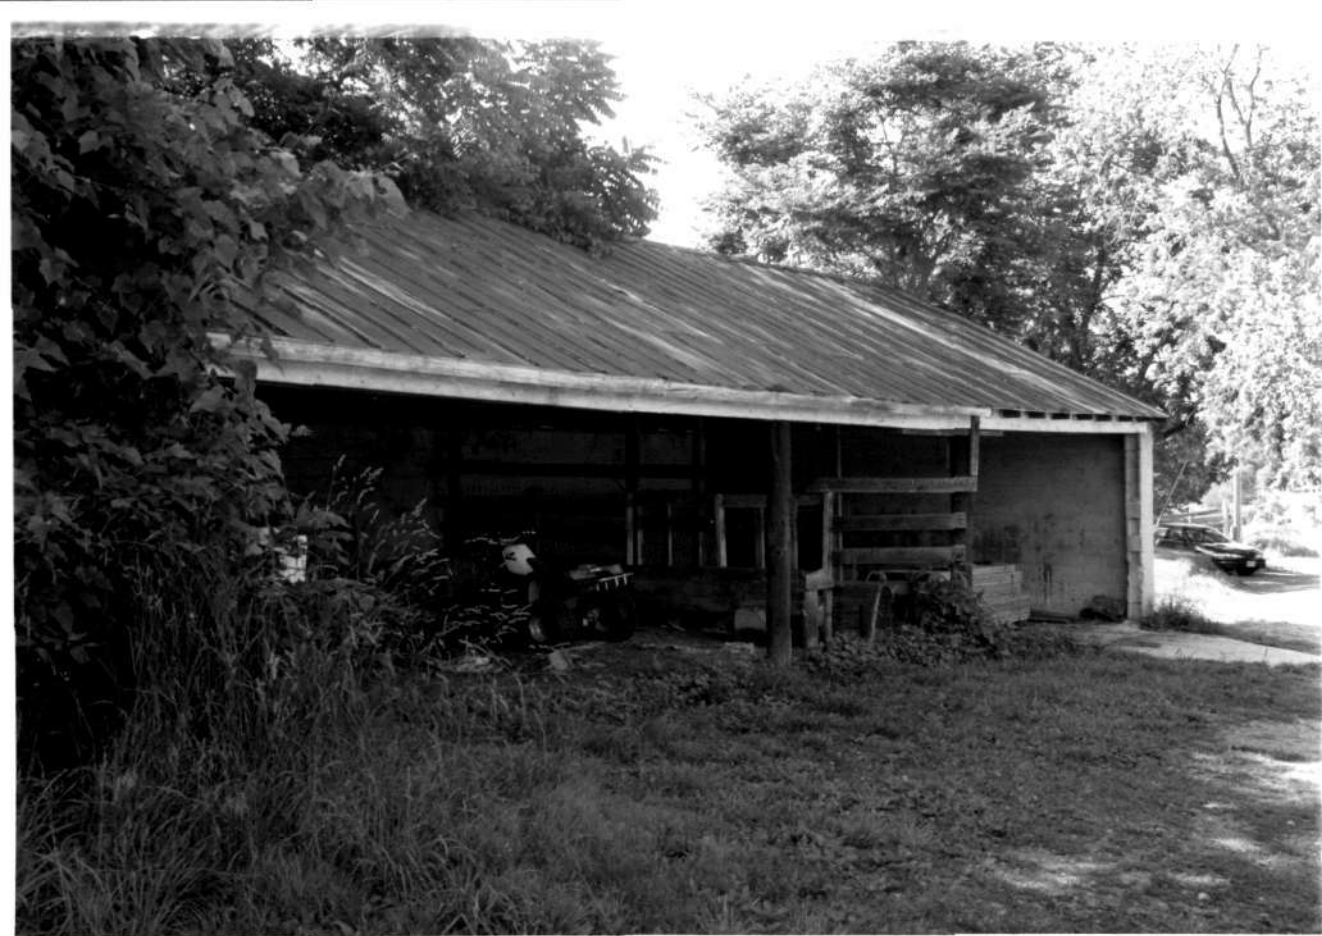
19/21

Gambrel-roof shed - NW corner

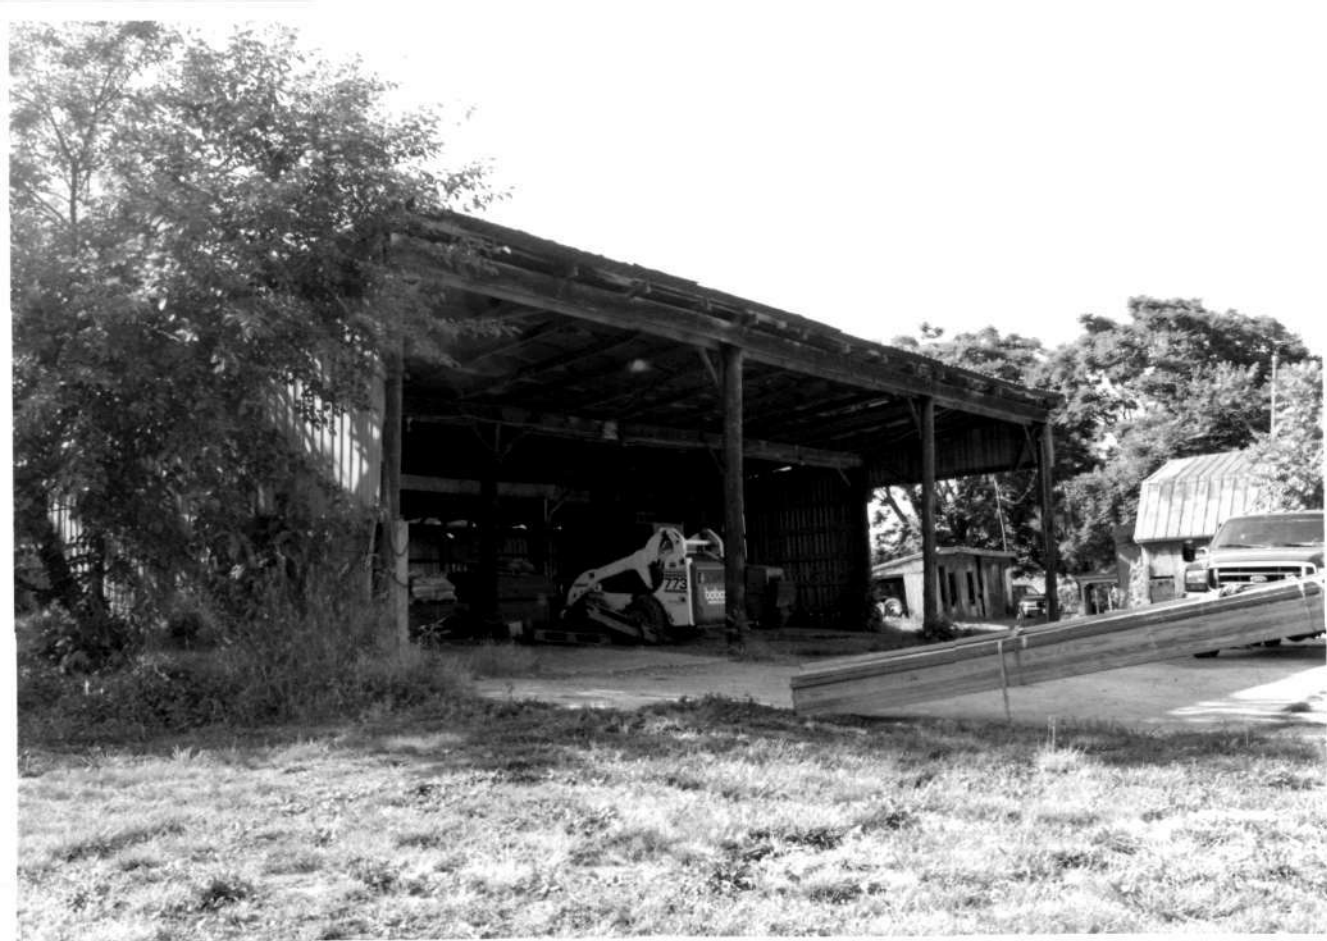
20/21

Small equipment shed- E elevation
